DELAWARE RIVER BASIN  
SCHUYLKILL RIVER  
MONTGOMERY AND PHILADELPHIA COUNTIES

PENNSYLVANIA  
NDS ID PA. 00896  
DER ID 51-1

# FLAT ROCK DAM

PHASE I INSPECTION REPORT  
NATIONAL DAM INSPECTION PROGRAM

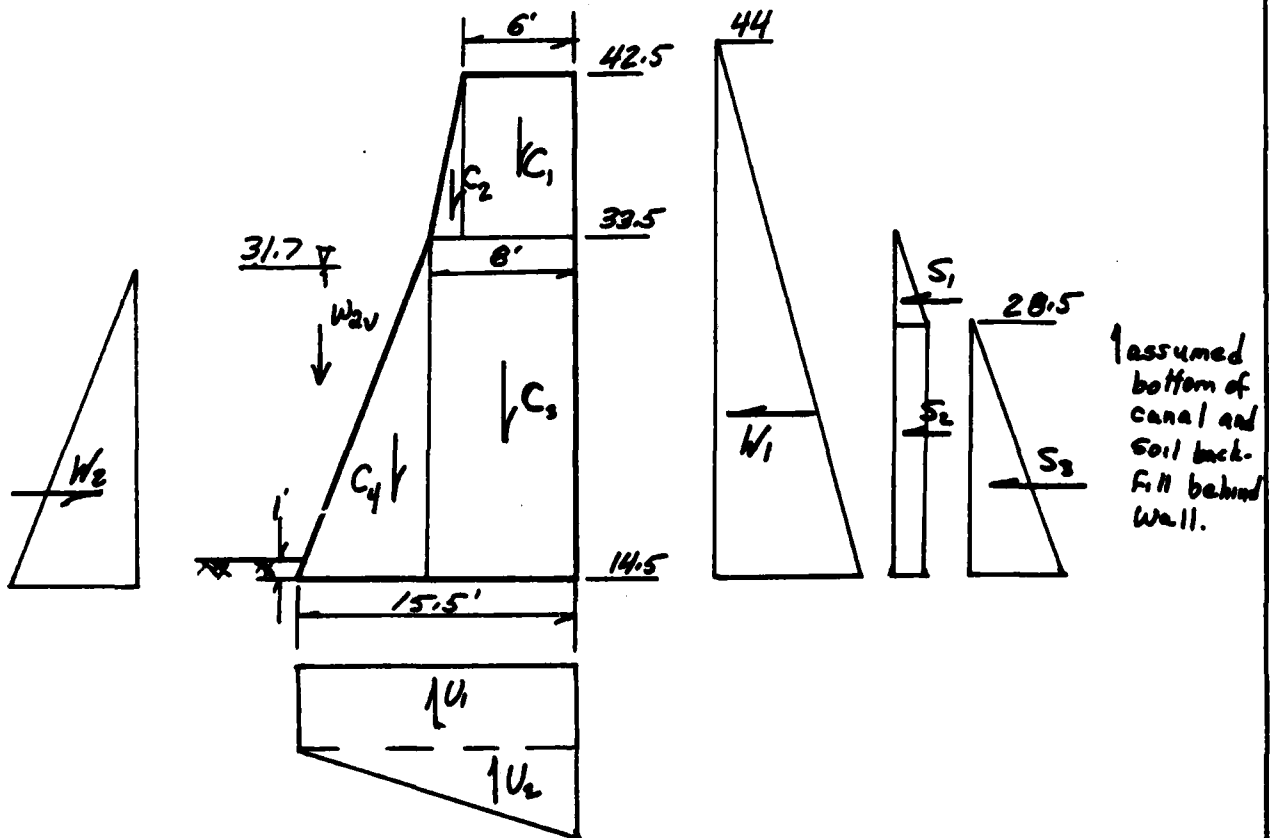
## Cross Section and Loadings

Use low section of wall at maximum height above river bed - location approximately 350' from dam center line.
